**Flood Control Project Maintenance
Levee Inspections**
LMA District Cover Sheet
Spring 2019 Levee Inspection Results

Reclamation District No. 2058 Pescadero

Spring 2019 Levee Inspection Results

Waterway			Bank	Unit Miles
Unit No. 01 Paradise Cut			Left	6.58
	Spring (March - May)	Summer (June - August)	(September - November) Fall	Winter (December - February)
Unit Maintenance Rating (Fall Only)				
Date of Inspection	5/6/2019 - 5/6/2019			
DWR Inspector	Alberto De Leon			
Accompanied By	Greg Pombo

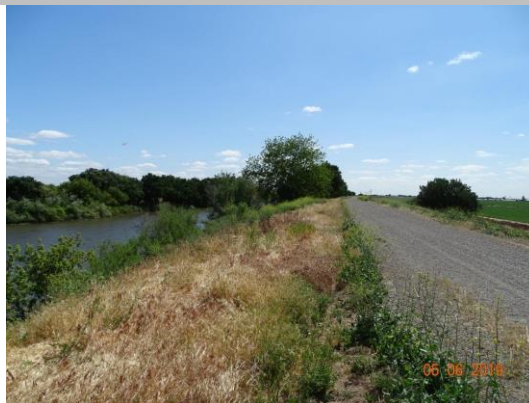
Photo 1 of 1 : SP_2019_RD2058_111_22_20190514_00054.jpg

Typical view of vegetation on waterside slope. (Spring 2019)

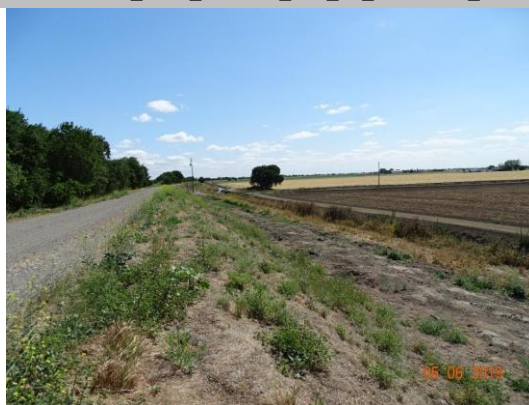
Photo 1 of 1 : SP_2019_RD2058_111_18_20190514_00055.jpg

Typical view of vegetation on landside slope. (Spring 2019)

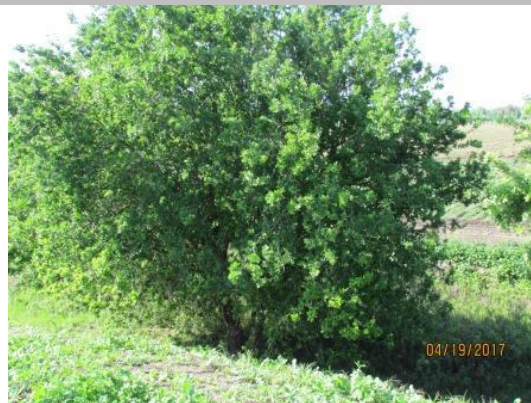
Photo 1 of 1 : SP_2019_RD2058_111_21_20190313_00012.jpg

View of the tree that needs to be trimmed.

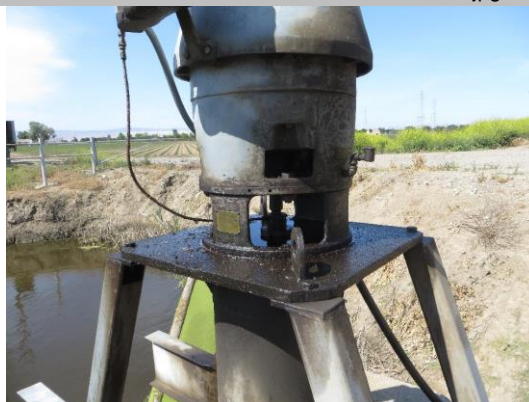
Photo 2 of 3 : UCIP_SP_2019_45843_74061.jpg

Comment Code						
Inspector Comment						
FS_ID:45843 DS_ID:22700 EP_NO: 5055 Repair Type: Non-Urgent Crossing Status: Found UCIP Comments: Excessive oil leakage. FIELD_STRUCT_DESC: 16-inch steel drainage discharge pipe through the levee, 3.8 feet below the crown. Drainage ditch on the landside (LS). Pump on a concrete sump on the LS. Siphon breaker under protective cover on the waterside (WS) slope. (To abandon the existing 12-inch pipe with concrete and install a new 16-inch pipe authorized under Permit No. 5055, 1965 - Stanley Electric Motor Company). 12-inch pipe grouted in place. [Additional Reference(s): DWR Levee Log, 2005. USACE San Joaquin O&M Manual 10, March 1964, (HLM 0.72)]. FS Date: 5/12/2015

LS view: closeup of pump showing excessive oil leakage.

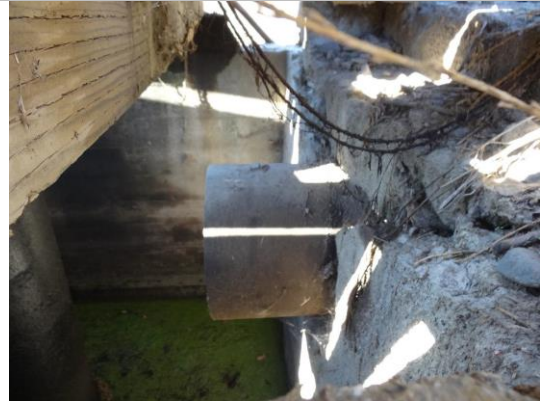
Photo 1 of 1 : UCIP_SP_2019_53531_45168.jpg

Comment Code					
Inspector Comment					
FS_ID:53531 DS_ID:22704 EP_NO: N/A Repair Type: No Action Needed Crossing Status: Found UCIP Comments: 12/07/2018 Need updated photos to show proper 12-inch pipe abandonment. If crossing was abandoned properly crossing will need to be removed from the LMA responsibility list. Also recommend updating photos for dsid 22700 (16-inch pipe) authorized under the same permit. (O. Magana - DWR UCIP) FIELD_STRUCT_DESC: *ABANDONED* 12-inch drainage discharge pipe of an unknown material through the levee, 18 feet below the crown. Pump on the landside (LS). Flap gate on the waterside (WS). (To abandon the existing 12-inch pipe with concrete and install a new 16-inch pipe authorized under Permit No. 5055, 1965 - Stanley Electric Motor Company). 12-inch pipe grouted in place. [Additional Reference(s): DWR Levee Log, 2005. USACE San Joaquin O&M Manual 10, March 1964, (HLM 0.72)]. FS Date: 5/12/2015

LS view: an abandoned pipe found in concrete sump.

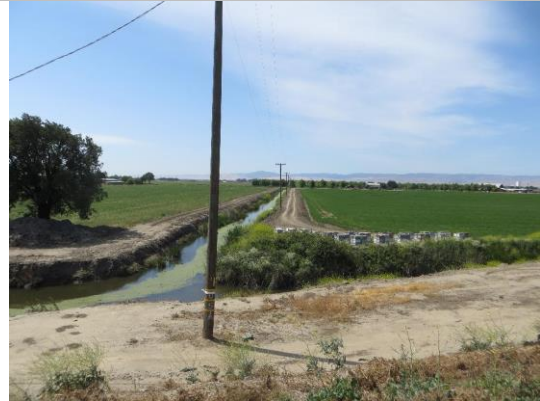
Photo 1 of 1 : UCIP_SP_2019_45847_74322.jpg

LM Start	1.21	Rating **	M	Issue No.	977
LM End	1.21	Issue Type +	En	Location *	
Category	Supplemental			GPS Latitude/Longitude	
				Start	End
Item	DWR UCIP Field Study			37.802249 °	37.802249 °
				-121.402183 °	-121.402183 °
DWR ID	22693				
Comment Code					
Inspector Comment					
FS_ID:45847 DS_ID:22693 EP_NO: 10426 Repair Type: Non-Urgent Crossing Status: Indicator Found UCIP Comments: Crossing needs to be marked. FIELD_STRUCT_DESC: 33-inch concrete encased steel sewer line through the levee, 17 feet below the crown. Manholes visible along Delta Avenue, but no other indicators visible at the levee. (Sewer line authorized under Permit No. 10426, 1975 - City of Tracy, care of CDM, Inc.). [Additional Reference(s): DWR Levee Log, 2005]. FS Date: 5/12/2015

View of LS. Alignment of Crossing to right of canal at dirt access road.

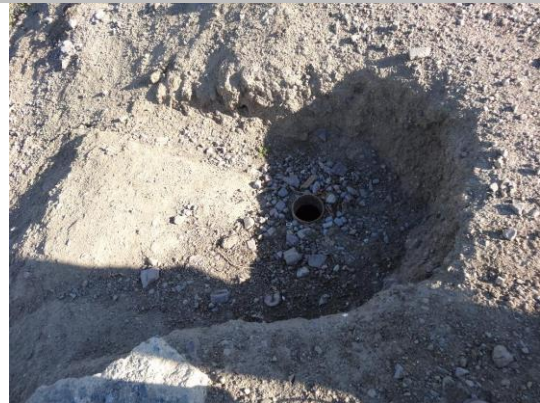
Photo 1 of 3 : UCIP_SP_2019_53374_45171.jpg

Comment Code						
Inspector Comment						
FS_ID:53374 DS_ID:22694 EP_NO: 11546 Repair Type: Urgent Crossing Status: Found UCIP Comments: 10/12/2018 Same as last inspection; keeping as Urgent due to erosion into levee prism (D. Sanoski - DWR UCIP).11/29/2016 Heavy erosion still present. Could be due to wave run-up as this is the only spot on levee not rock revetted. Greg Pombo (RD2058) indicated permits for endangered species prevent rock revetment. (K. Fazel - UCIP)05/12/2015 Erosion on west side of pipe at W/S toe. (K. Fazel - UCIP) FIELD_STRUCT_DESC: 1 of 2: 18-inch steel drainage discharge pipe through the levee, 2 feet below the crown. Pump in drainage ditch on the landside (LS). Siphon breaker with cover on the waterside (WS) shoulder. Electrical service pole at the LS toe. (18-inch pipe and pump authorized under Permit No. 11546, 1976 - Reclamation District No. 2058). [Additional Reference(s): DWR Levee Log, 2005]. FS Date: 10/12/2018 9:59:00 AM

WS view: siphon breaker hole. Siphon breaker removed for repair.

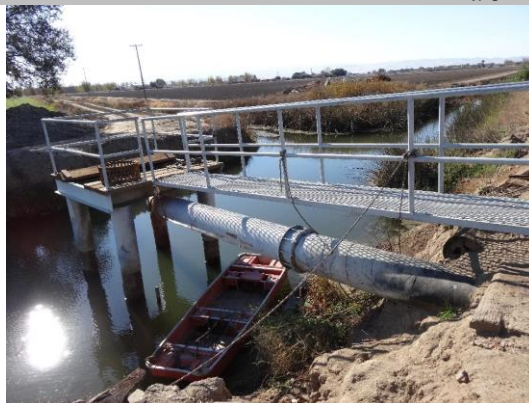
Photo 2 of 3 : UCIP_SP_2019_53374_45170.jpg

LS view: pipe, pile structure, and pump platform in drain ditch.

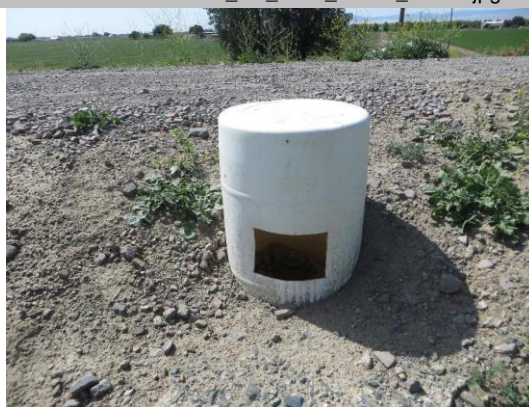
Photo 3 of 3 : UCIP_SP_2019_53374_74320.jpg

Siphon Breaker on WS shoulder.

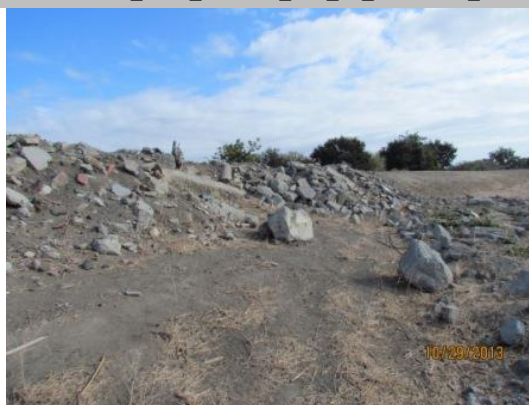
Photo 1 of 1 : SP_2019_RD2058_111_11_20190313_00005.jpg

View of the concrete with rebar placed on the landside slope.

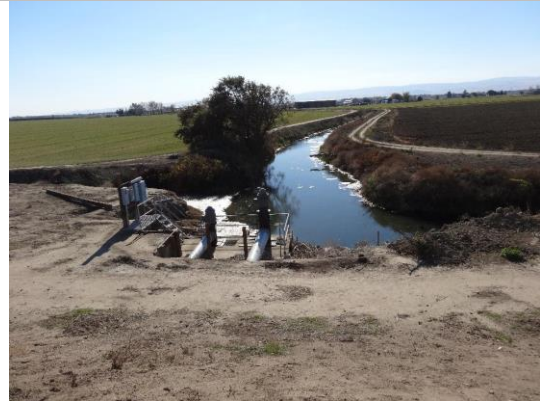
Photo 3 of 3 : UCIP_SP_2019_45865_74325.jpg

Pump on concrete pad at LS toe.

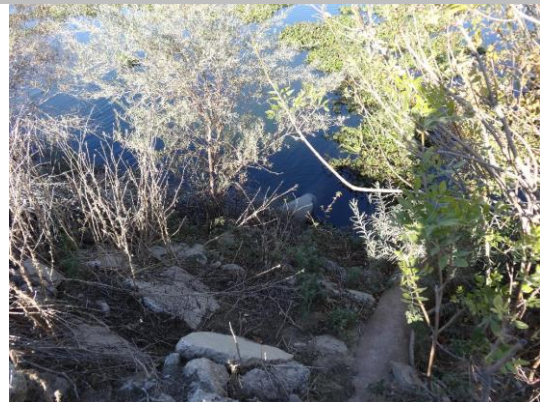
Photo 1 of 3 : UCIP_SP_2019_51699_45192.jpg

LM Start	2.12	Rating **	M	Issue No.	980
LM End	2.12	Issue Type +	Ma	Location *	
Category	Supplemental			GPS Latitude/Longitude	
				Start	End
Item	DWR UCIP LMA Responsibility			37.803886 °	37.803886 °
				-121.386271 °	-121.386271 °
DWR ID	22706				
Comment Code					
Inspector Comment					
FS_ID:51699 DS_ID:22706 EP_NO: N/A Repair Type: Non-Urgent Crossing Status: Found UCIP Comments: Leaky and damaged siphon breaker on waterside shoulder.. FIELD_STRUCT_DESC: 16-inch steel drainage discharge pipe through the levee, 8 feet below the crown. Pump on a concrete sump in a drainage ditch on the landside (LS) toe. Siphon breaker on the waterside (WS) shoulder. [Additional Reference(s): USACE San Joaquin O&M Manual 10, March 1964, (HLM 2.14), 12-inch pipe referenced]. FS Date: 5/13/2015

WS view: exposed steel pipe (right) on channel bank.

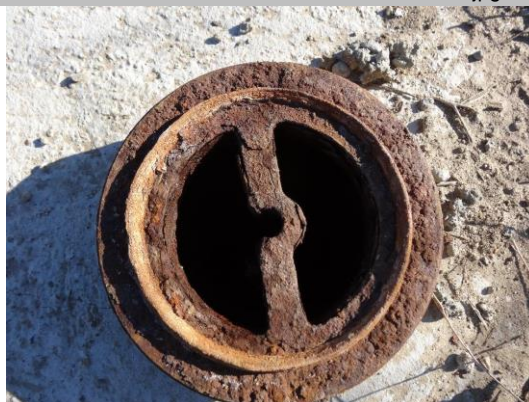
Photo 3 of 3 : UCIP_SP_2019_51699_45190.jpg

WS view: Upper part of the siphon breaker missing.

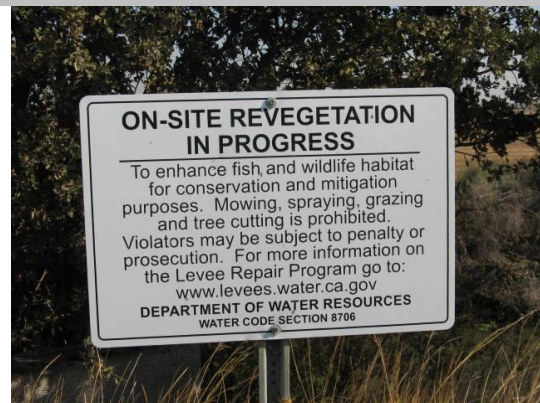
Photo 1 of 1 : SP_2019_RD2058_111_20_20190313_00011.jpg

11/08/2011 Revegetation site, cannot trim or cut vegetation in this area.

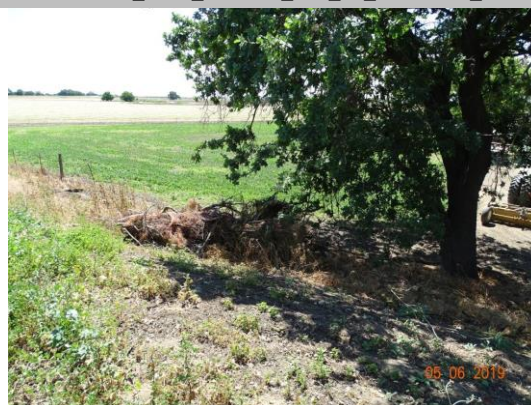
Photo 1 of 1 : SP_2019_RD2058_111_34_20190514_00056.jpg

View of pruning pile on landside slope. (Spring 2019)

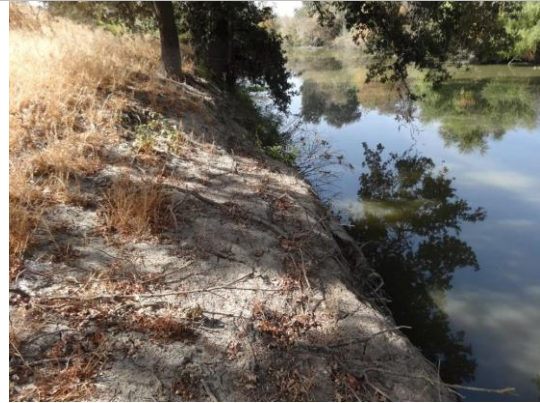
Photo 1 of 4 : SP_2019_RD2058_111_1_20190313_00001.jpg

Comment Code					
Inspector Comment					
10/10/2017: No significant change observed.					
07/20/2016: No significant change observed.					
08/04/2015: No significant change observed.					
08/26/2014: No significant change observed.					
08/28/2013: No significant change observed.					
07/26/2012: The site has been visited, and no significant change has been observed.					
09/02/2011: This site was not visited due to the time limit.					
09/22/2010: No significant change observed. Minor pocket erosions are lined at the lower bank. Two large Oak and Willow trees are on mid-slope and bench. The remaining bench was re-measured and found to be approximately 10 feet. There was no indication of active erosion on site during the site visit.					
08/05/2010: Recommended for annual assessment and monitoring of the site during flood events, per CLRO.					
07/23/2009: No major change observed since last visit; site is a 200-ft. long near-vertical berm erosion; recommend annual assessment and monitoring of the erosion site, per CLRO CES Evaluation 2008 Report; Site # is the same site previously reported as RM4.0,LM4.51; previously rated "U".

Direct view of the pocket erosion site.

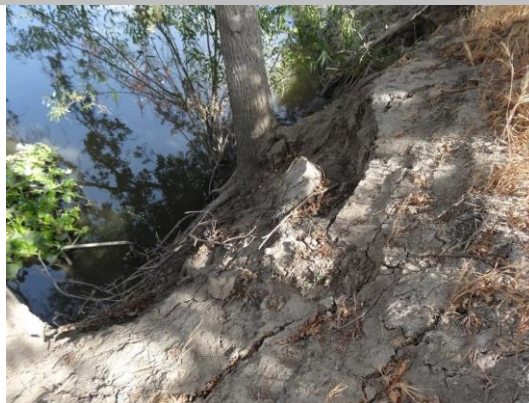
Photo 2 of 4 : SP_2019_RD2058_111_1_20190313_00002.jpg

Direct view of the erosion near a tree.

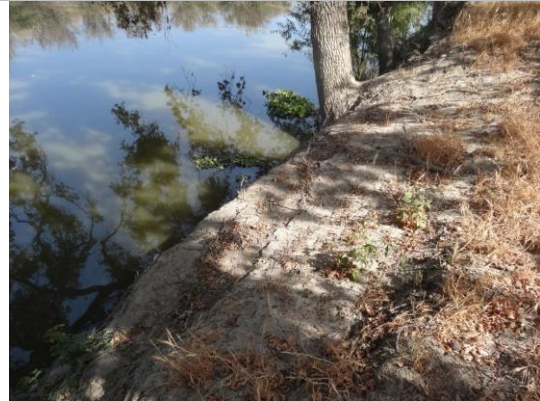
Photo 4 of 4 : SP_2019_RD2058_111_1_20190313_00004.jpg

Direct view of the erosion near a tree.

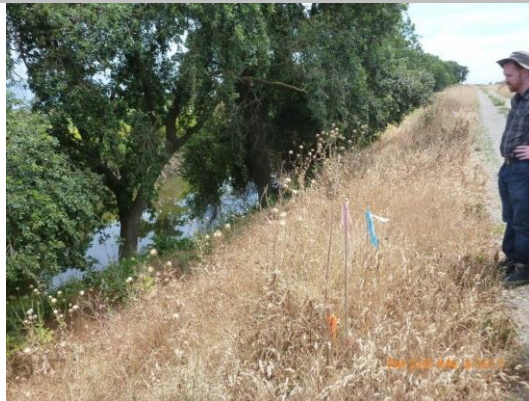
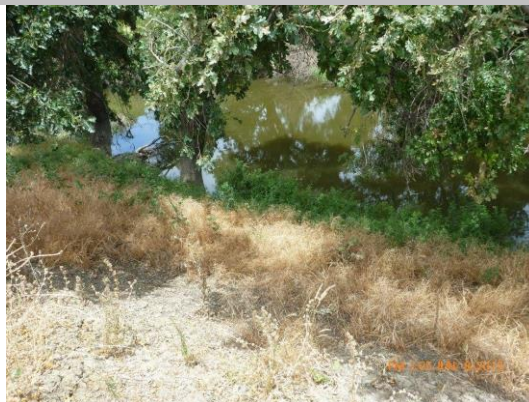
Notes: vegetation too dense to evaluate damage. Erosion on the waterside is greater than three feet tall into the levee prism as of Fall 2017 Inspection. Turned back over to Evaluators for re-assessment.

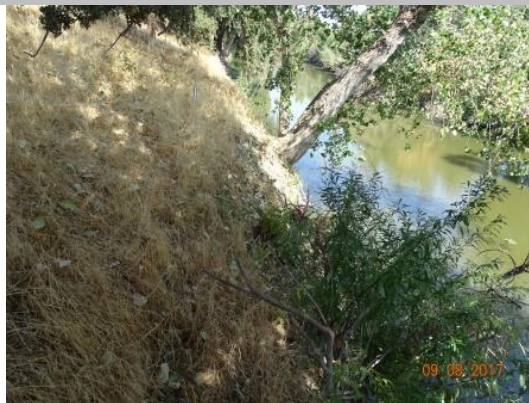
Photo 3 of 3 : SP_2019_RD2058_111_15_20190313_00009.jpg

Downstream view of the erosion site.

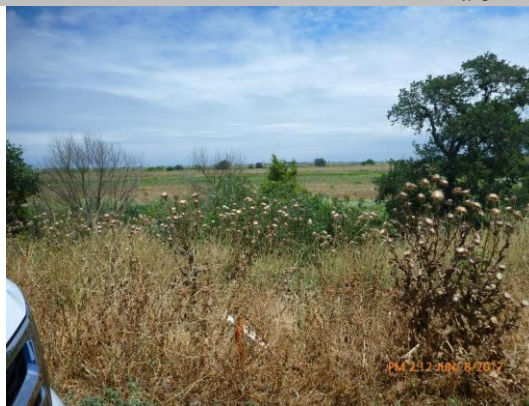
Notes: vegetation too dense to evaluate damage. The erosion has about a 3 foot vertical cut at the waterside levee toe as of the Fall 2017 Inspection. Turned back over to Evaluators for re-assessment.

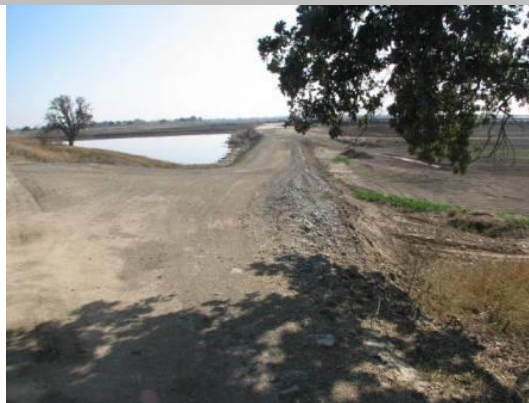
Photo 1 of 3 : SP_2019_RD2058_111_29_20190313_00014.jpg

11/08/2011 New ramp has been constructed by dairy farmer connecting his barns to the levee.

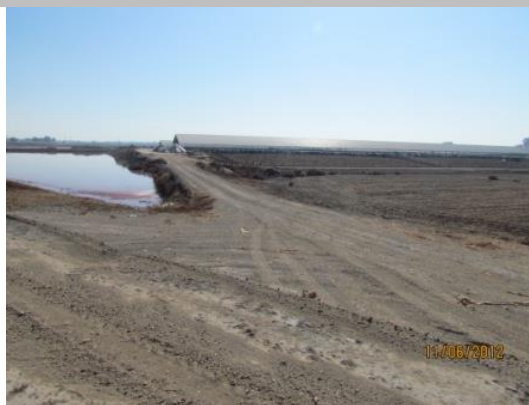
Photo 2 of 3 : SP_2019_RD2058_111_29_20190313_00015.jpg

Completed new ramp constructed by dairy farmer connecting his barns to the levee.

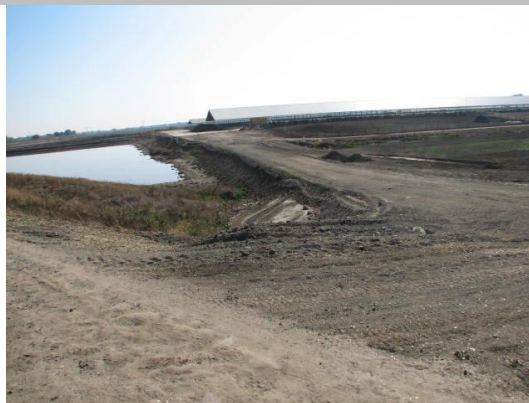
Photo 3 of 3 : SP_2019_RD2058_111_29_20190313_00016.jpg

11/08/2011 New ramp has been constructed by dairy farmer connecting his barns to the levee.

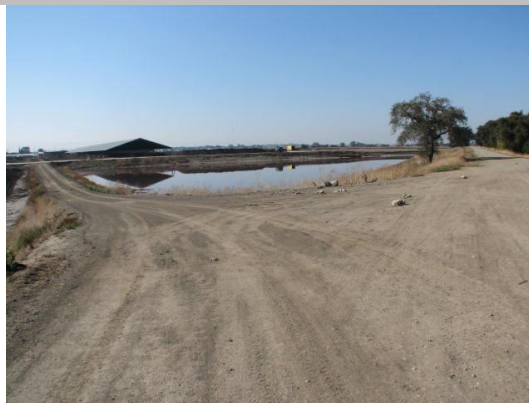
Photo 1 of 3 : SP_2019_RD2058_111_30_20190313_00017.jpg

11/08/2011 Photo shows existing middle ramp to the levee which has been raised.

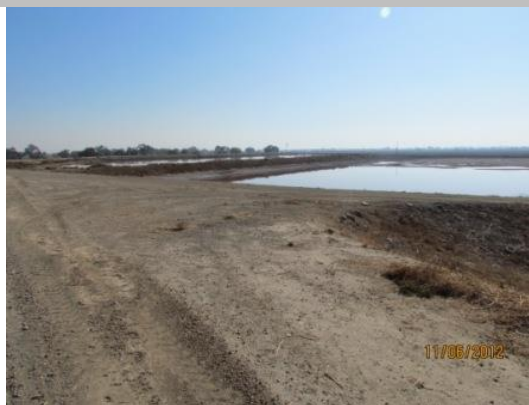
Photo 2 of 3 : SP_2019_RD2058_111_30_20190313_00018.jpg

Completed ramp constructed by dairy farmer connecting his barns to the levee.

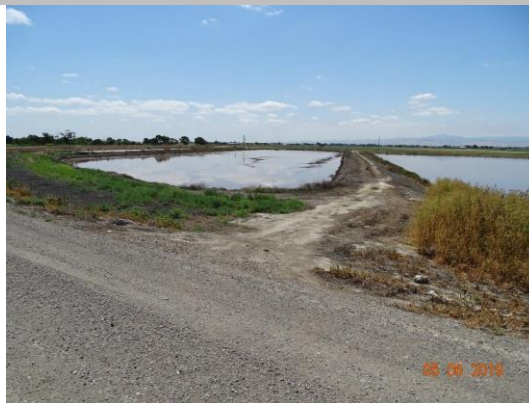
Photo 1 of 1 : SP_2019_RD2058_111_35_20190514_00057.jpg

View of ramp on landside slope providing access from dairy farm to levee crown. (Spring 2019)

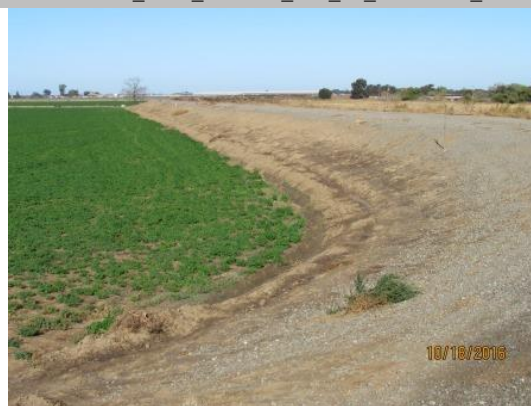
Photo 1 of 1 : SP_2019_RD2058_111_19_20190313_00010.jpg

View of the ditch at the landside levee toe.

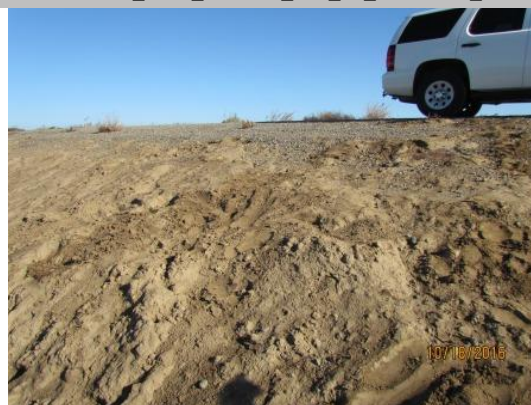
Photo 1 of 1 : SP_2019_RD2058_111_28_20190313_00013.jpg

View of the rodent holes on the levee slope.
